**Metlakatla Indian Community Site
Non-Sampling Site Inspection
Annette Island, Alaska
TDD: 00-01-0013**

Contract: 68-W6-0008
December 2000

Region 10
START

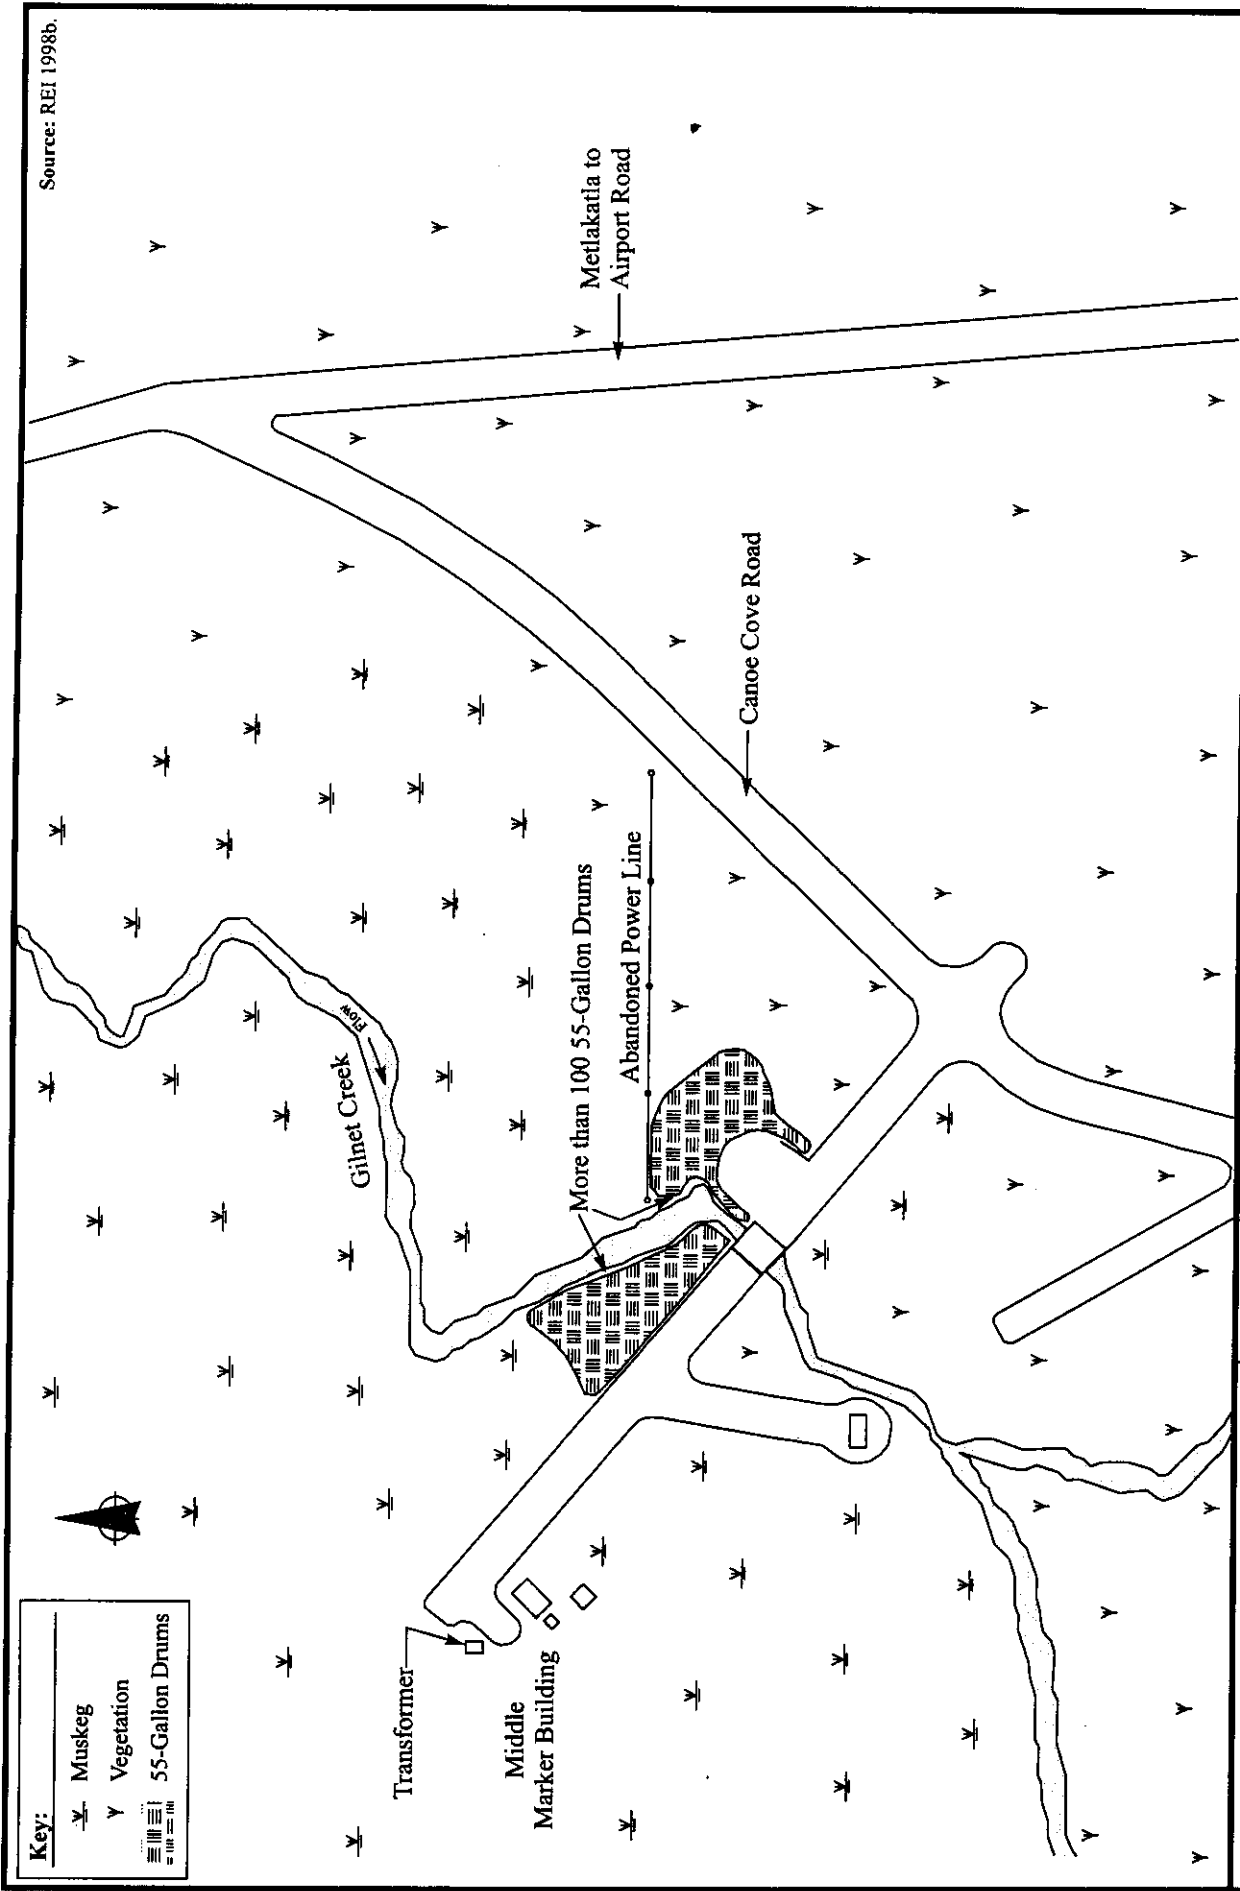
The Middle Marker Facility was built by the FAA as a navigational aid. The facility consists of a small building that contains two small inactive transformers with an estimated quantity of 2 gallons of dielectric oil. A pile of twenty-four 55-gallon drums were observed along the north side of the road and southeast of the facility (Figure 3-12). No visible markings were noted on the drums; some were open-top style and others were bung-top style and appeared full. Electrical equipment at the facility has not been sampled; hence, PCBs are a potential contaminant of concern. (E & E 1992)

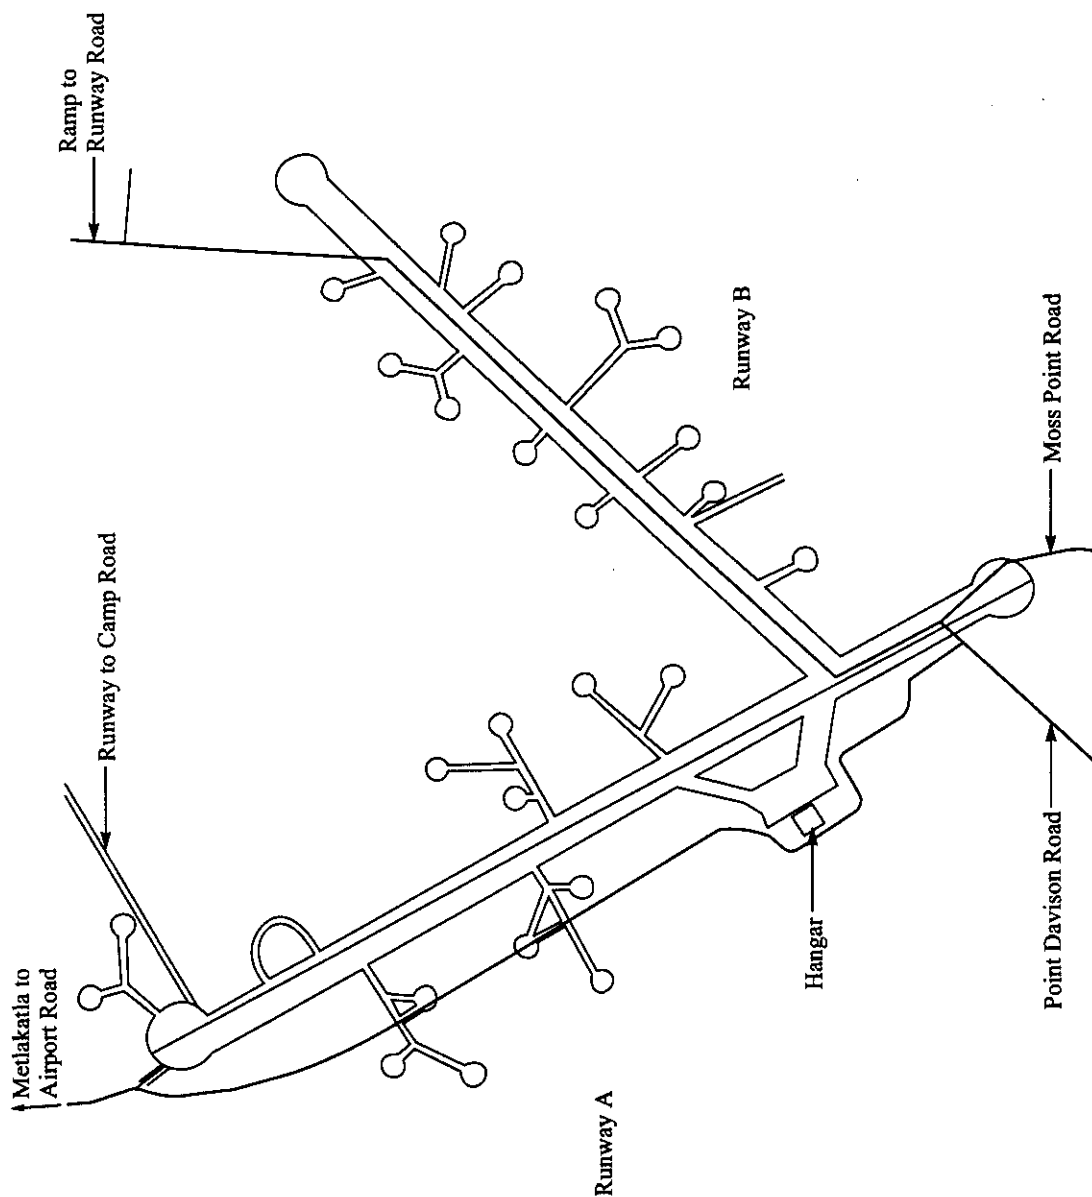
Figure 3-16
SITE 33A LANDING FIELD

The Landing Field, constructed during WW II, consists of two runways: a 7,500-foot asphalt runway (Runway A) oriented northwest to southeast and a 6,000 feet gravel runway (Runway B) oriented northeast to southwest (Figure 3-16). The Landing Field was included in the LRI of the Metlakatla Peninsula performed by REI. Numerous 55-gallon drums of asphalt were observed along the runways, mostly in airplane parking revetments. Reportedly, herbicides were periodically applied to the runway edges by the FAA to inhibit vegetation growth. Numerous areas where vegetation was stressed or absent were observed during the LRI. A total of three surface soil samples were collected: two at the north end of Runway B and one along the east side of Runway A, south of the Runway B intersection. The following contaminants were detected in the sample collected along Runway A: RRO (93 mg/kg), barium (37.3 mg/kg), chromium (184 mg/kg), lead (62 mg/kg), mercury (0.05 mg/kg), 2-butanone (550 µg/kg), and toluene (290 µg/kg). The first sample collected at the north end of Runway B contained DRO (110 mg/kg), RRO (720 mg/kg), barium (12 mg/kg), and lead (170 mg/kg). The second sample collected from the north end of Runway B contained DRO (180 mg/kg), RRO (1,200 mg/kg), barium (11.7 mg/kg), and lead (160 mg/kg). No herbicides, pesticides, or PCBs were detected in the Landing Field surface soil samples. (REI 1998b)

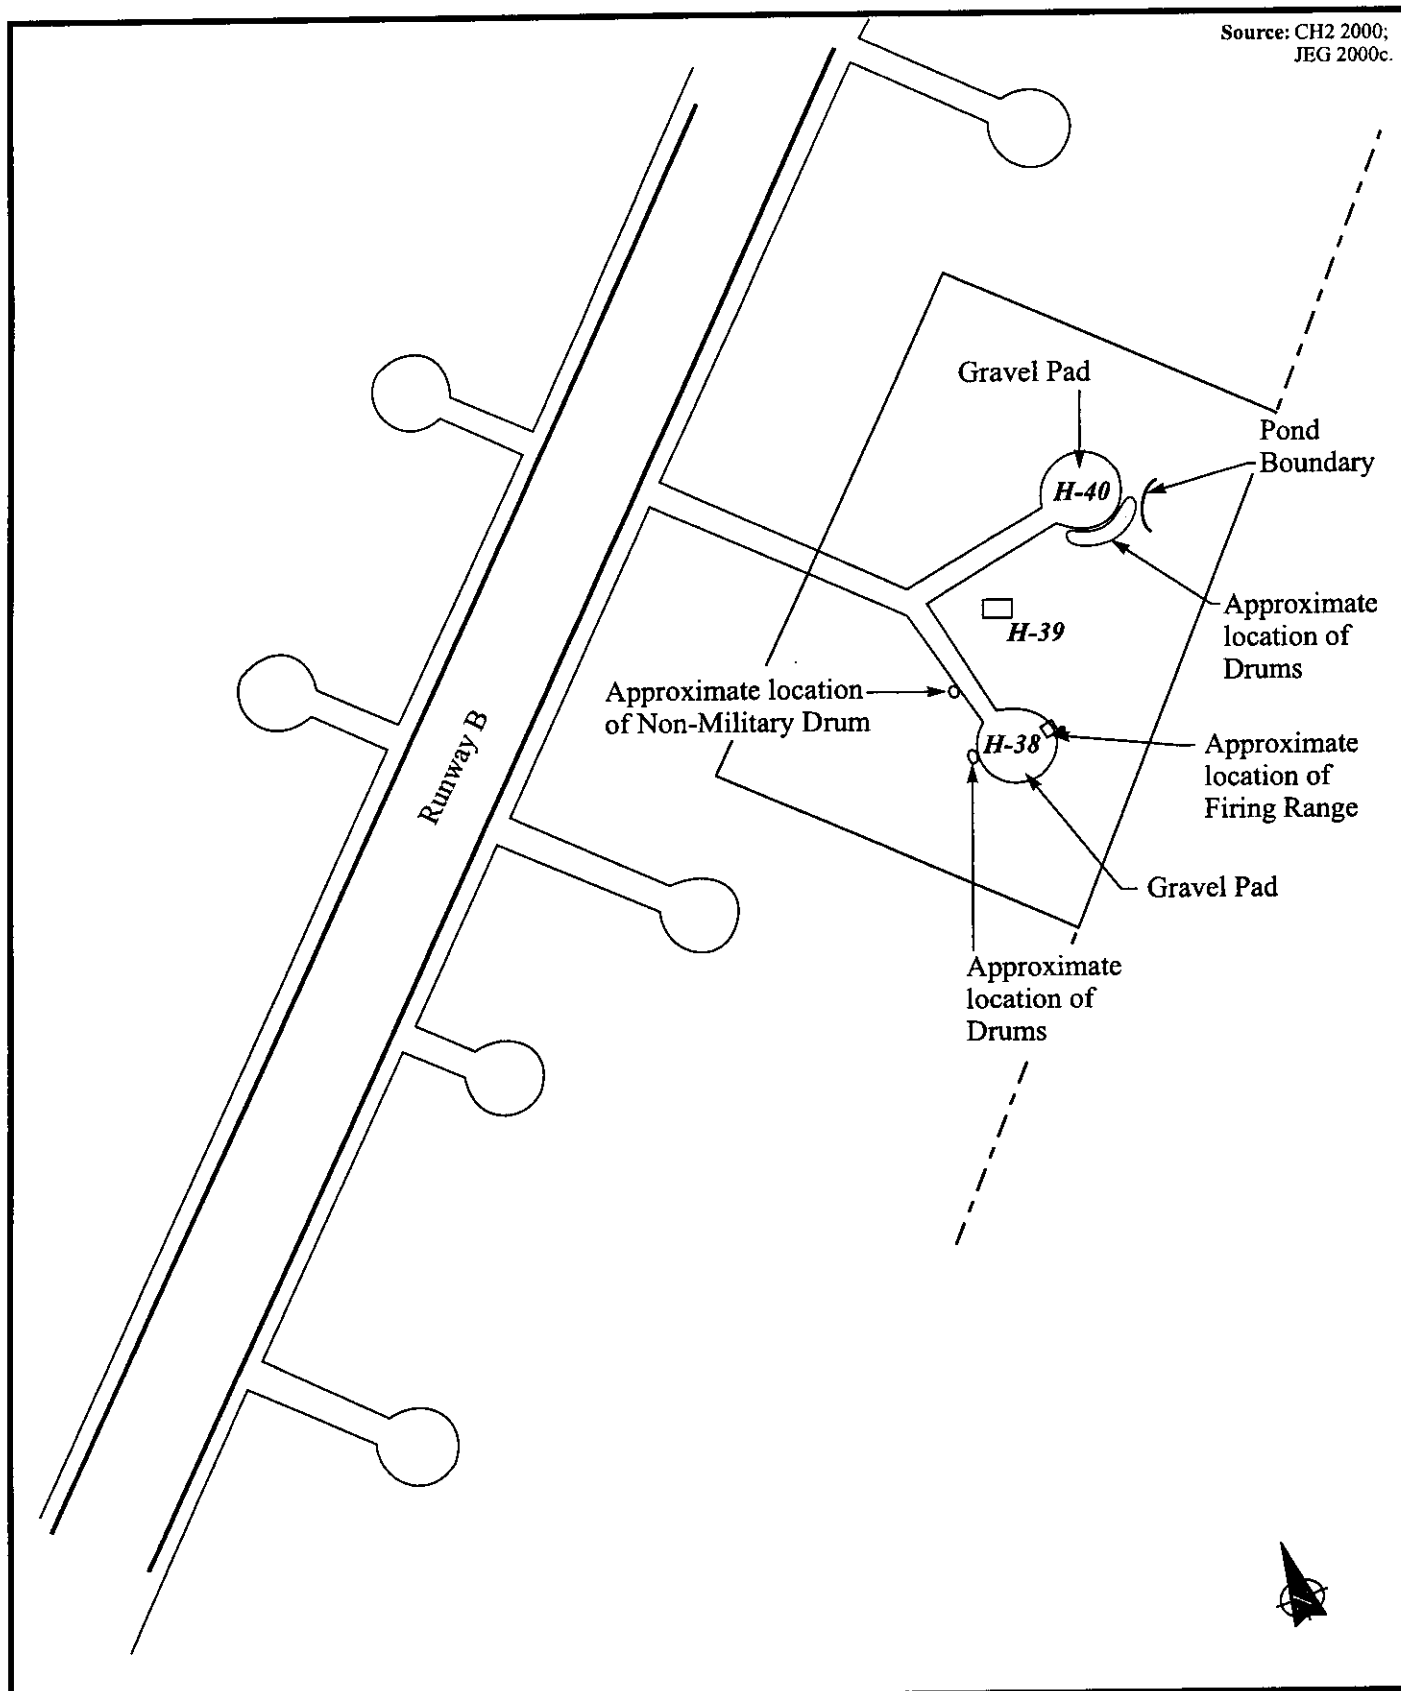
The USCG Storage Area consists of a taxiway and two circular parking revetments in the south central portion of Runway B (Site 33A; Figure 3-17). The site was originally leased by the USCG from the CAA. Specific operations at the site are unknown, however, a 1952 USCG map labeled the site "*Ammo. Storage Area*" implying that munitions were stored at the site. A 1946 USACE plot plan indicates that Revetments H-38, H-39, and H-40 are located at the site. Approximately two hundred 55-gallon drums, filled with what is believed to be asphalt, were reportedly abandoned at Revetment H-40 by numerous agencies, including the USN, the USAF, and the BIA. (CH2 2000)

The location of this site is identical to the Former USCG Storage Area (Site 33B). It is unclear whether this site refers to a historic military firing range or to informal firing ranges established by local residences at Revetments H-38 and H-40 (Figure 3-17). Lead has been detected in soil at both Revetments H-38 and H-40. It is possible that this site was created for administrative reasons such as identifying a different lead agency or different restoration activities. Restoration at this site includes investigating and removing lead in site media. Restoration efforts are estimated at \$100,000 and are scheduled for fiscal years 2000-2002. The FUDS Program associated with USAED, Alaska, is the lead agency for restoration activities at the site. (MOU 1999)

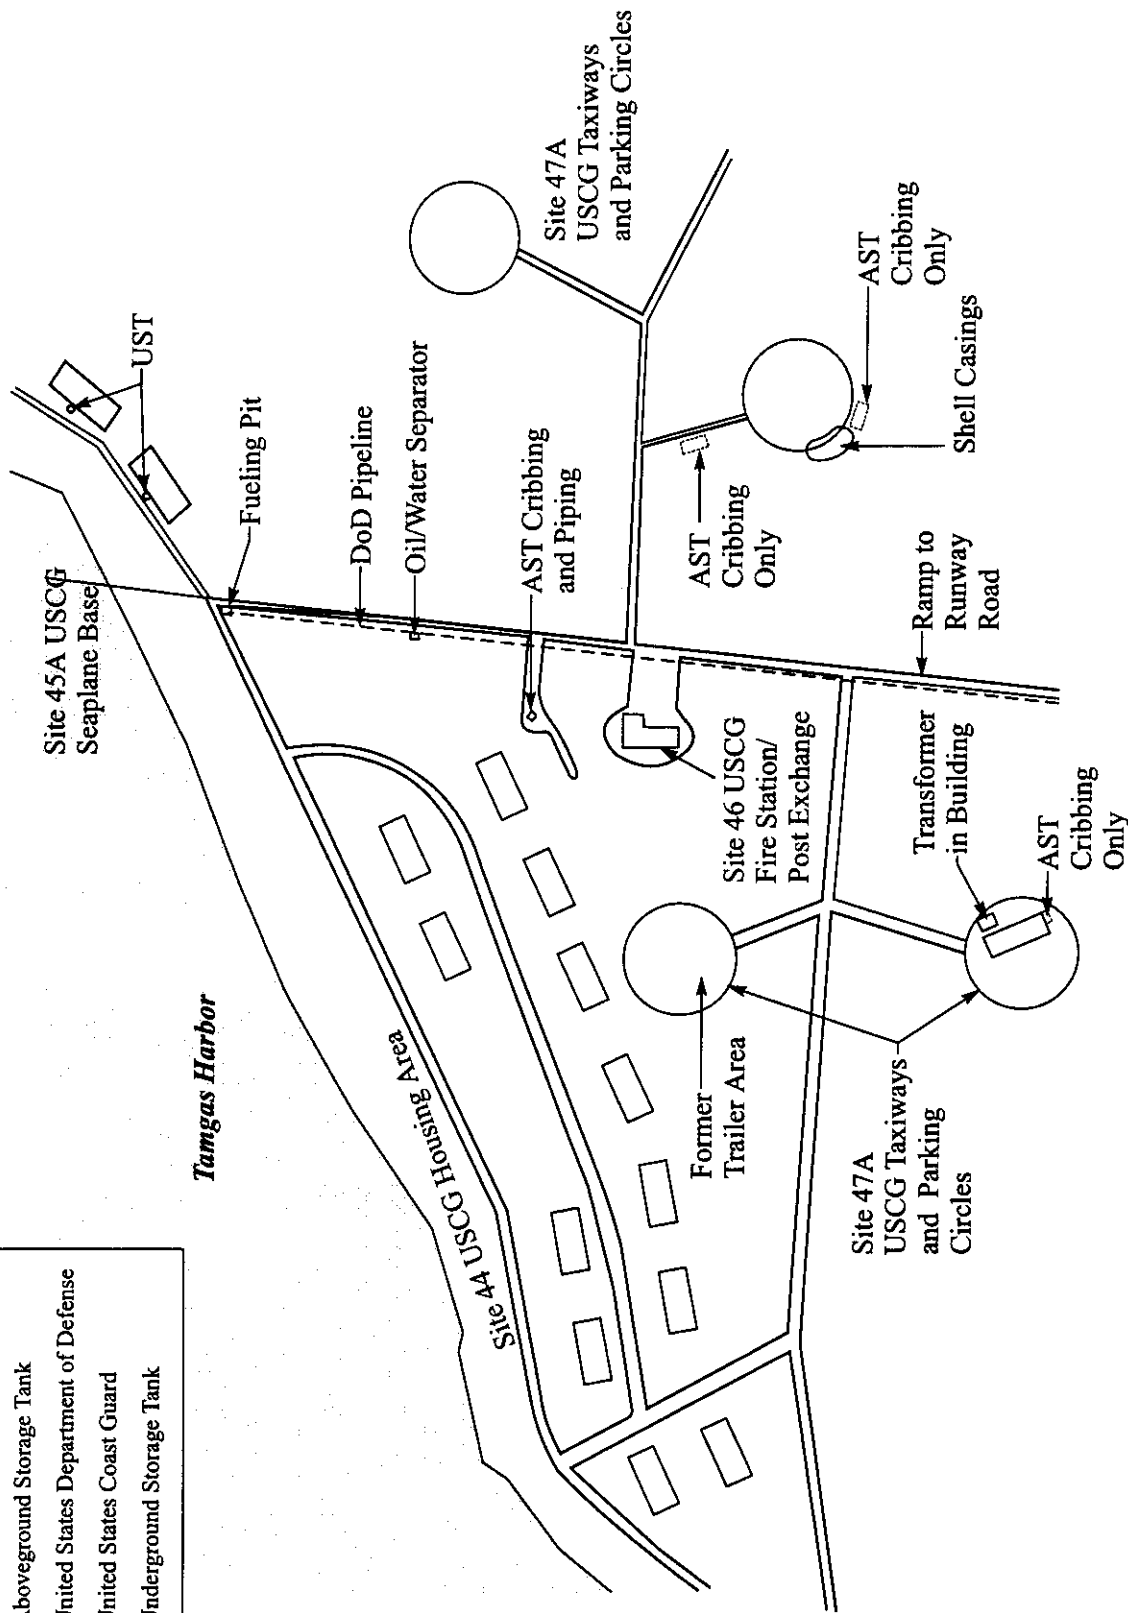
Figure 3-20			
SITE 44 USCG HOUSING, SITE 45A USCG SEAPLANE BASE, SITE 46 USCG FIRE STATION/POST EXCHANGE, AND SITE 47A USCG TAXIWAYS AND PARKING CIRCLES			
Date:	TDD No.	PAN No.	Dwg. No.
12/7/00	00-01-0013	EA1301SIT0	EA1301 3-20
			Pubs. No.
			S523

The USCG Housing area consisted of 14 residential buildings along Tamgas Harbor near the Seaplane Base (Site 45A). All of the buildings were removed from Annette Island and brought to Sitka in 1977 when the USCG moved its operation. Thus, only the concrete foundations remain at this location (Figure 3-20). The two large buildings east of the Seaplane Ramp each had an associated heating oil UST. Each tank currently contains a mixture of water and product. A soil sample collected at one of the UST fill pipes contained DRO (96 mg/kg), RRO (35 mg/kg), and lead (6 mg/kg). A 6,000-gallon AST supplied heating fuel to the other 12 residential buildings; the AST has been removed, but the concrete saddles remain. A soil sample collected near the AST saddles contained DRO (740 mg/kg), RRO (18 mg/kg), and lead (3 mg/kg). (REI 1998b)

The Seaplane Base consisted of an approximately 150-foot gravel-covered seaplane ramp, wood frame support facilities, a fueling valve box, and a 3-inch fuel pipeline that ran alongside the Ramp to Runway Road (Figure 3-20). Remains at the site consist of the gravel ramp, dilapidated wood frame buildings, and miscellaneous wood and metal debris. (CH2 2000)

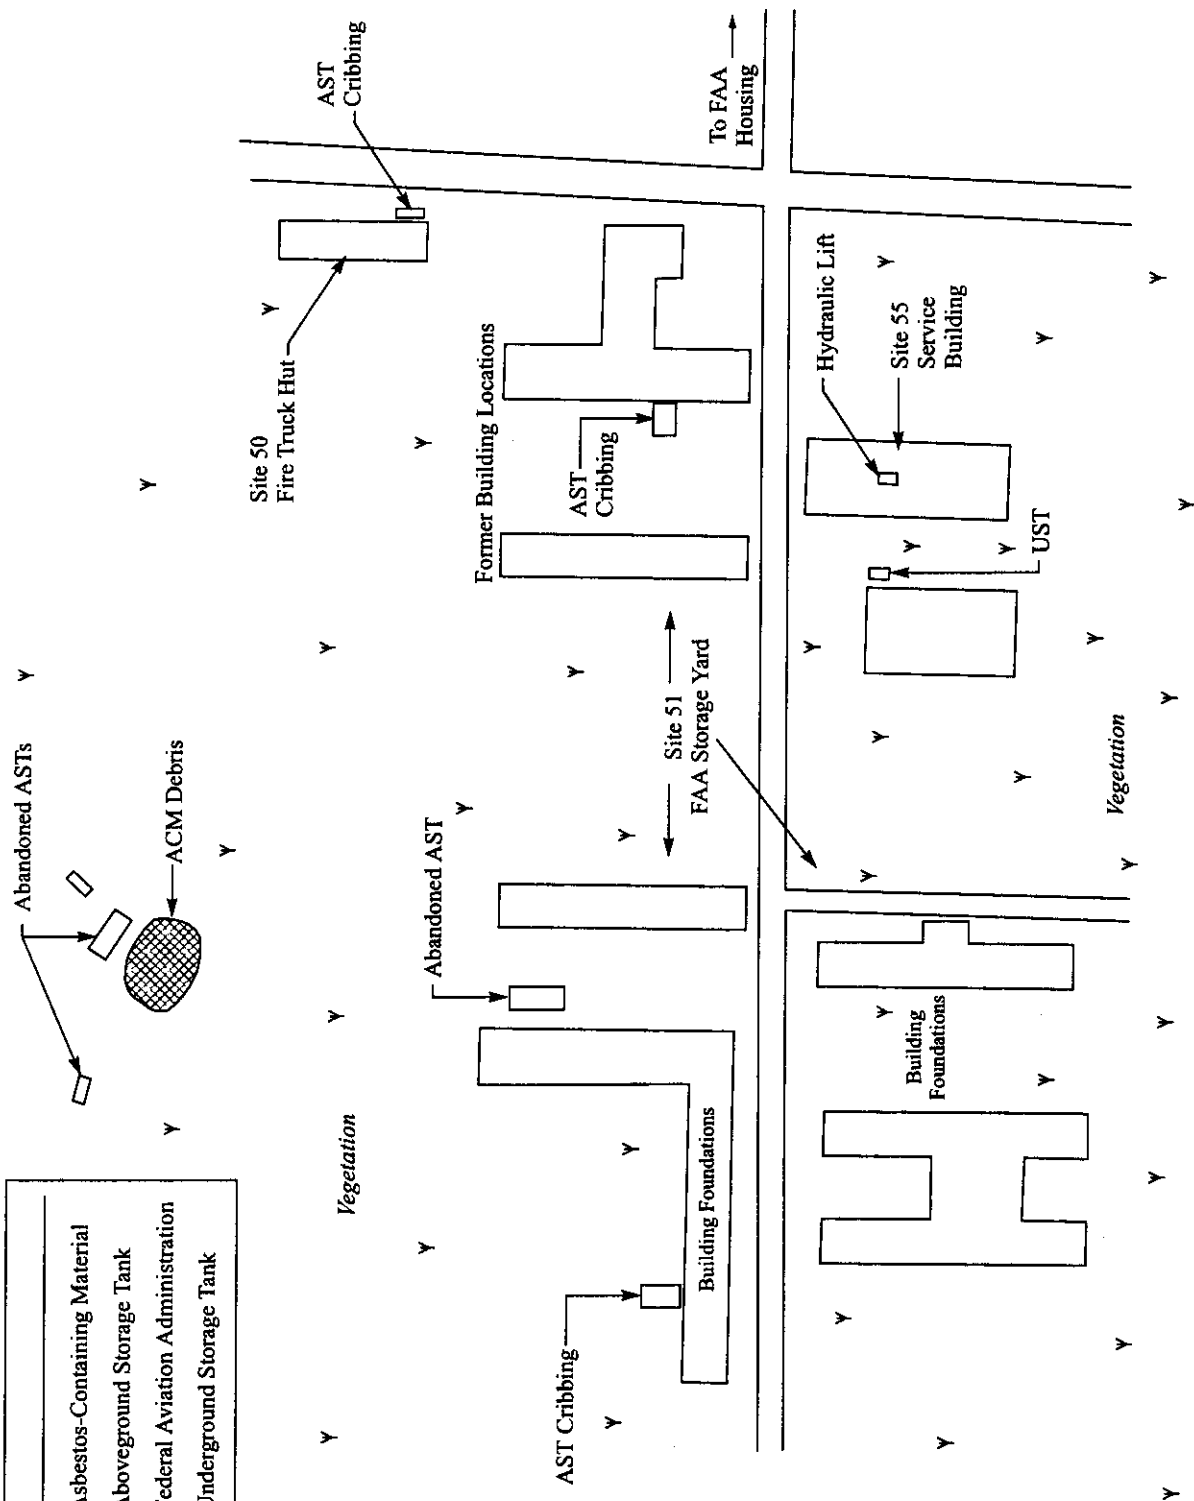
Figure 3-22

The Fire Truck Hut consisted of an approximately 20-by-80-foot metal quonset hut with a concrete foundation (Figure 3-22). The building housed a fire truck and a boiler room, which was used to keep the building heated and the fire truck operational year-round. Wood cribbing for an AST was located on the southeast side of the building. Two soil samples were collected in the vicinity of the AST cribbing. One soil sample contained DRO (1,300 mg/kg), RRO (40 mg/kg), and lead (12 mg/kg) while the second soil sample contained DRO (1,500 mg/kg), RRO (200 mg/kg), and lead (26 mg/kg). (REI 1998b)

The FAA Storage Yard was a level, 150-by-200-foot gravel area used to store a multitude of airfield operations equipment (Figure 3-22). During the REI LRI at the site in 1998, the following materials were present at the site: a runway sweeper, a small crane, a passenger ramp, a metal portable catwalk, a snow plow attachment, a welder, an insulated pressure tank, three ASTs, two sets of AST cribbing, steel piping with cementitious coating, FAA water pipeline insulation, metal barricades, small

The FAA Service Building was used by the FAA as a garage facility (Figure 3-22). The garage contained a trench, hydraulic floor hoist, and associated piping. Remains at the site consist of a concrete foundation and building debris. A UST was located on the west side of the former service building; a soil sample was collected near the UST fill pipe. The soil sample contained DRO (1,600 mg/kg), RRO (20 mg/kg), and lead (424 mg/kg). (REI 1998b)

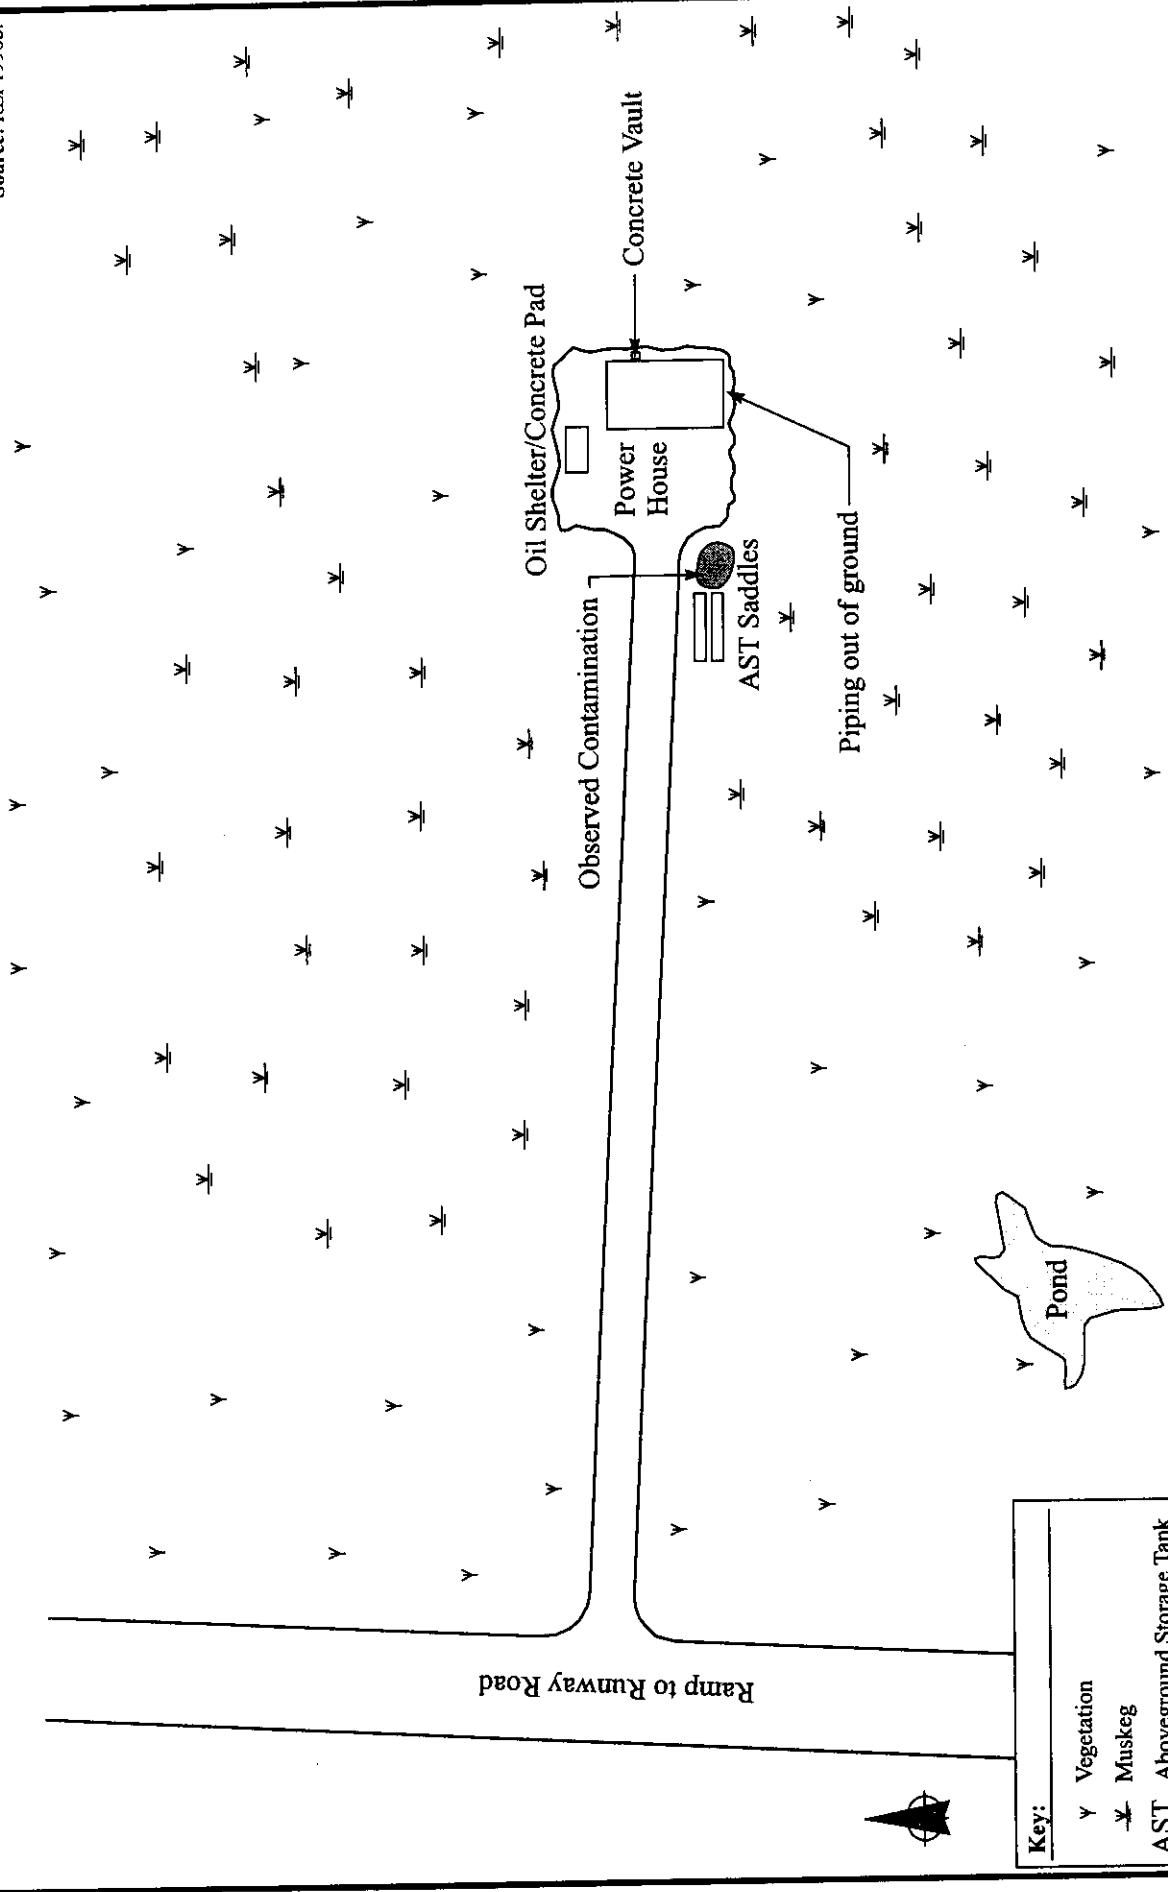
Remains at the Power House consist of a 30-by-40-foot wood-framed structure with a concrete foundation that accommodated five to six electrical generators (Figure 3-27). Lead-based paint may have been used during building construction. A concrete vault is located east of the building and a concrete pad is located north of the building. Two concrete saddles are located west of the building and were assumed to originally support an AST. Piping, stained soil, and a strong petroleum odor were present on the east side of the concrete saddles. A soil sample collected in this location contained DRO (280,000 mg/kg), RRO (1,700 mg/kg), and lead (330 mg/kg). (REI 1998b)
